# Built Asset Refurbishment

## Town of Victoria Park - Higgins Park Reserve

# case study

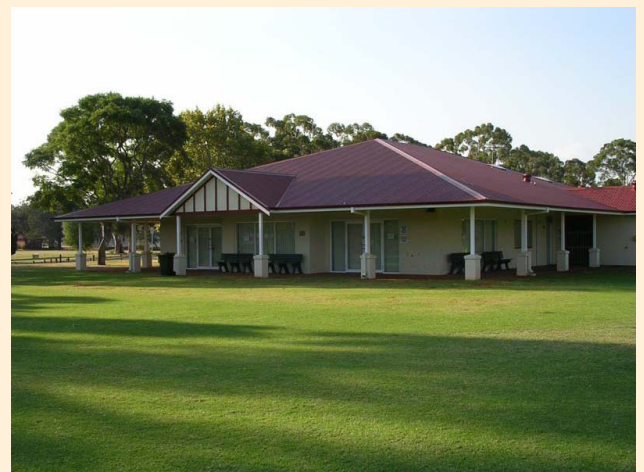
Higgins Park Reserve Club Rooms Building viewed from the southwest. Shows open veranda to three elevations (east, south and west), new gable end facing south and Colorbond clad roofing which replaces the tiled roof which previously facilitated illegal entry to the building.

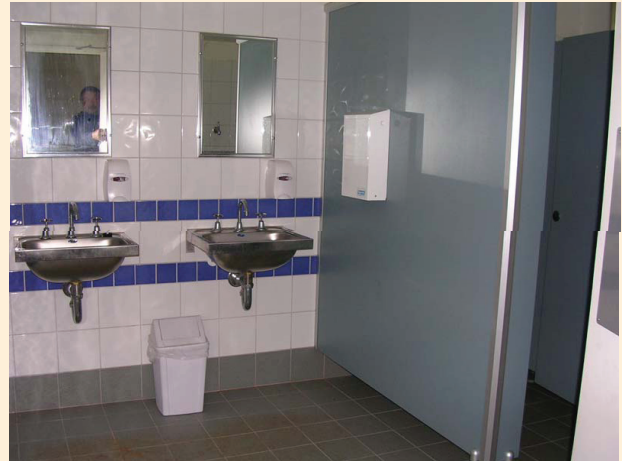
New female toilets showing low maintenance high durability finishes.

- Low maintenance/high durability finishes used in ablution areas.
- Minimal painted areas thus reducing long term maintenance costs.
- High maintenance timber floors were replaced with concrete.
- Spring loaded taps were installed to reduce water wastage.
- Low energy luminaires were installed.
- Naturally aspirated exhaust fans were installed.
- Roof insulation was installed to improve heating/cooling of the facility.

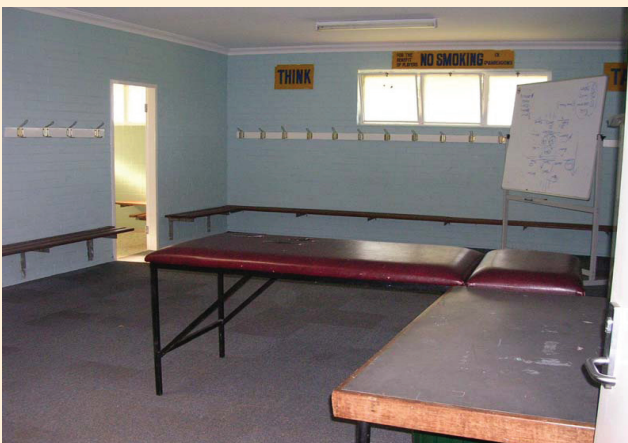
Team change rooms which have been refurbished.
